Contains information pertaining to Mr. Maples¹ first B-29, "Draggin Lady;" such as photographs of the aircraft and its crew, historical data relating to the loss of the aircraft, crew rosters, etc.

Aircraft Towing Accident Report for B-29 Serial Number 42-24694.

**Aircraft Towing Accident, Damaged Tail Section, Depot Maintenance Hanger,
Kearney Army Air Field, Kearney, Nebraska at 1830 CWT on 27 October 1944.**

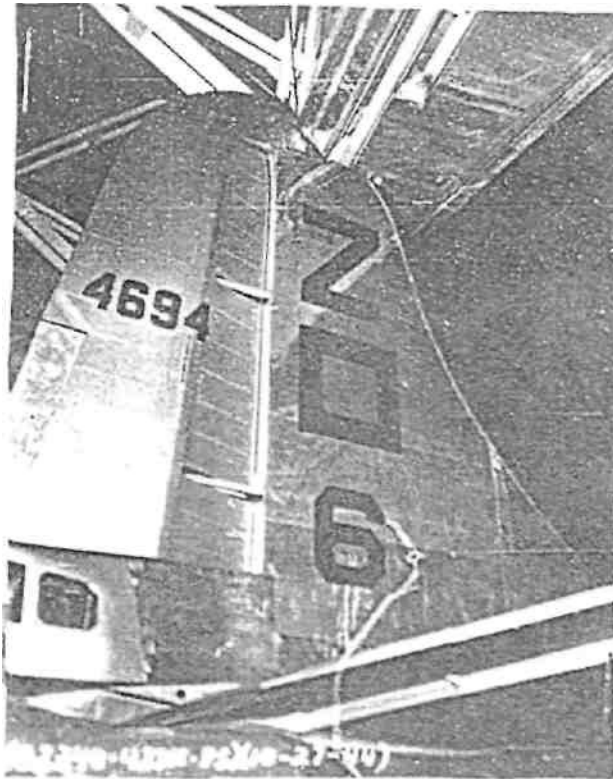
Close up view looking West, showing vertical stabilizer in contact with hanger.

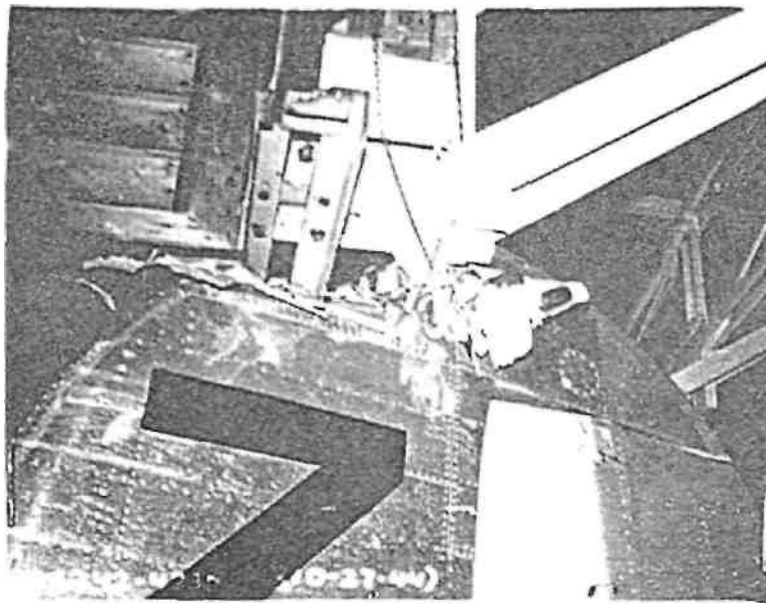
A. Vertical fin damaged from leading edge at rib station 176.55 to rear fin spar, and from fin rib station 176.55 to tip. Damage necessitates skin replacement, deicer channel replacement from station 168.45 to rear spar, and replacement of 5 each false ribs at fin tip.

Close up view showing damage to vertical stabilizer.

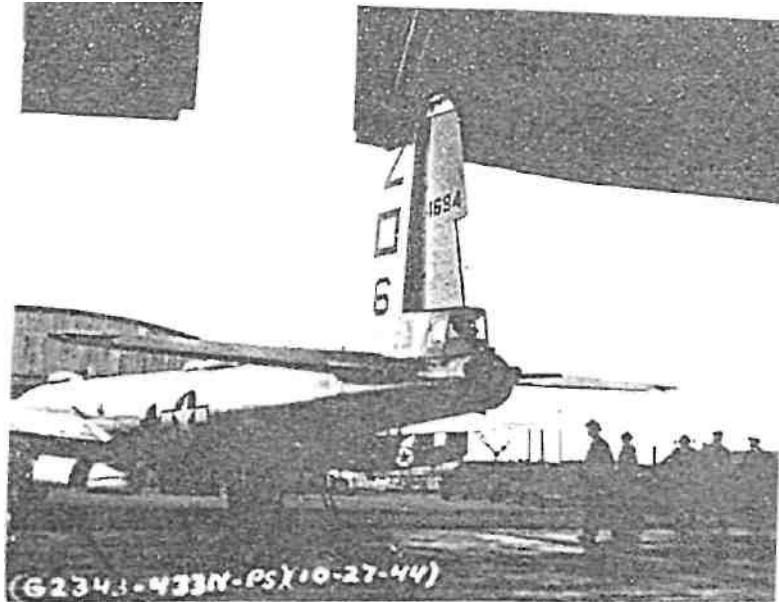
View looking North, showing opening in hangar to allow clearance for vertical stabilizer and point of contact of stabilizer with hangar.

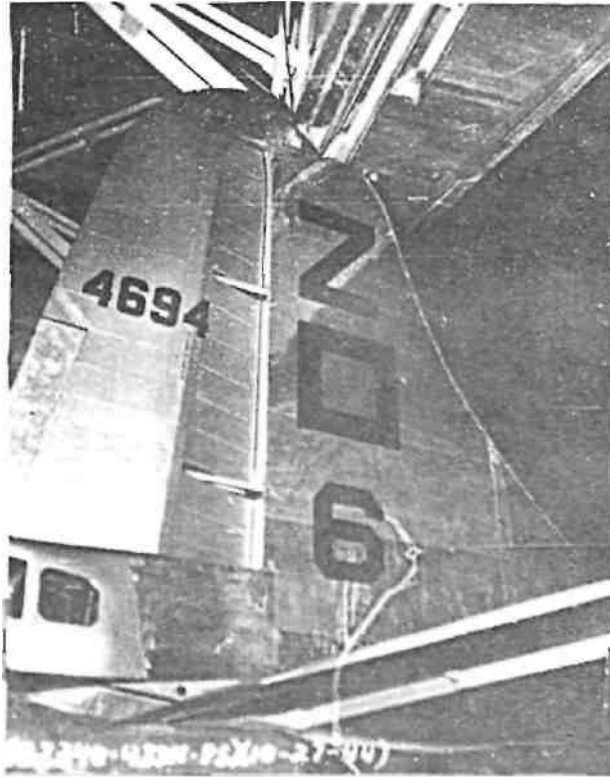
Close up view looking West, showing vertical stabilizer in contact with hanger.

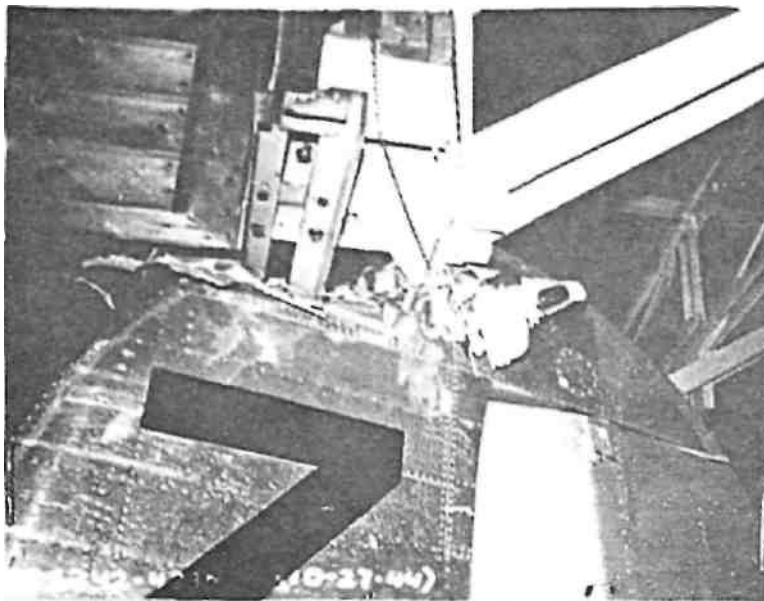
A. Vertical fin damaged from leading edge at rib station 176.55 to rear fin spar, and from fin rib station 176.55 to tip. Damage necessitates skin replacement, deicer channel replacement from station 168.45 to rear spar, and replacement of 5 each false ribs at fin tip.

Close up view showing damage to vertical stabilizer.

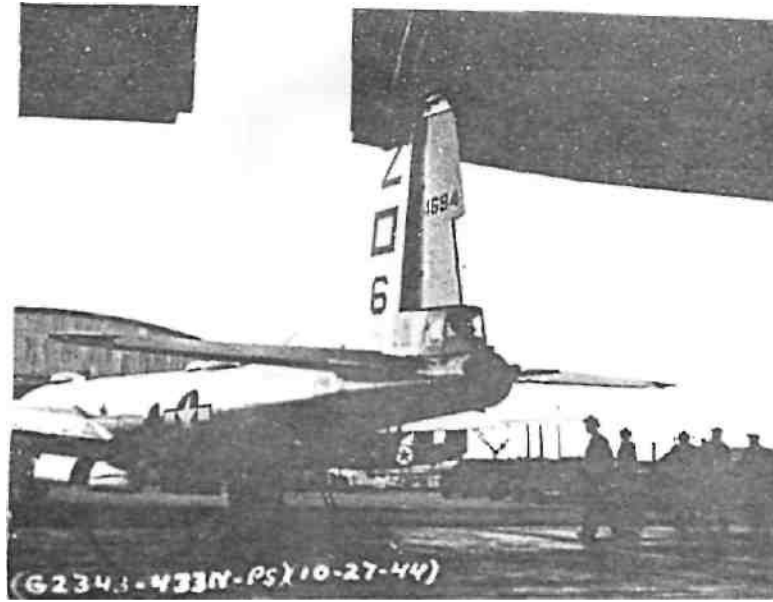
View looking North, showing opening in hangar to allow clearance for vertical stabilizer and point of contact of stabilizer with hangar.

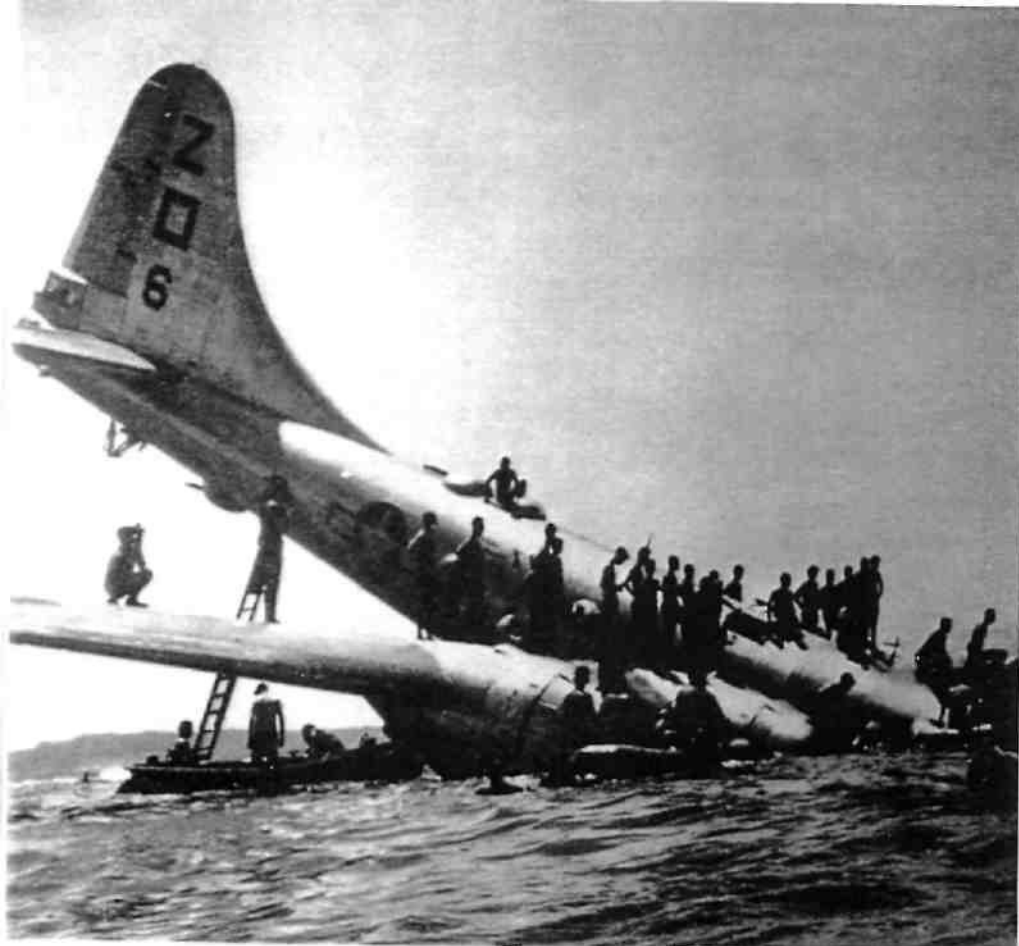
Boeing B-29 Superfortress, "Draggin Lady," lost on February 23, 1945, off the Island of Saipan, Marianas Group. Three lives were lost. The cause of the crash was multiple engine failures. This photograph has been on display in the Smithsonian Institution's National Air And Space Museum in Washington, D.C.

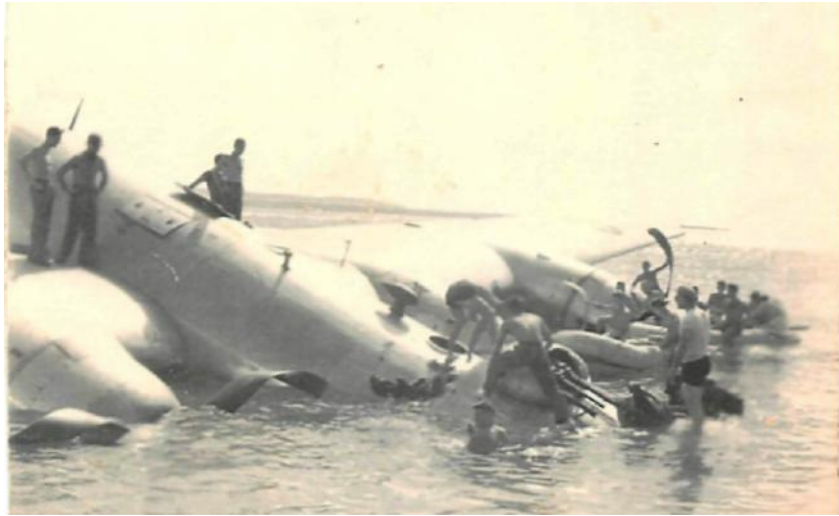
Another view of "Draggin Lady" in the water after the crash. Note the bent propellers and the man in the raft. (Photograph from the Charles R. Maples collection).

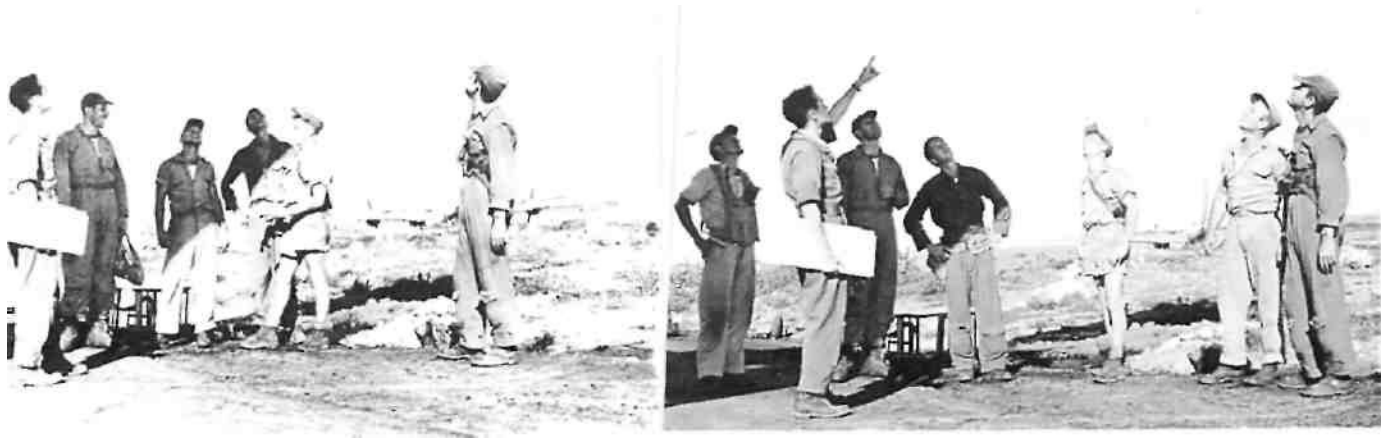
In the photographs above, Captain Patrick Calhoun and some of the "Draggin Lady" crew are looking at some minor flak damage on their aircraft following a mission. Staff Sergeant Harry Gerson, Radar Operator, pointing, seems to be saying: "They got us right there in the national insignia ... See!" In the photograph at left, Mr. Maples is standing fourth from the right. In the photograph at right, he is standing second from right. (Charles R. Maples collection).
